PROJECT MEMORANDUM
SCE WEST OF DEVERS UPGRADE PROJECT

To: John Forsythe, Project Manager, CPUC
From: Vida Strong, Aspen Project Manager
Date: August 15, 2019
Subject: Monitoring Report #75: August 4 to August 10, 2019

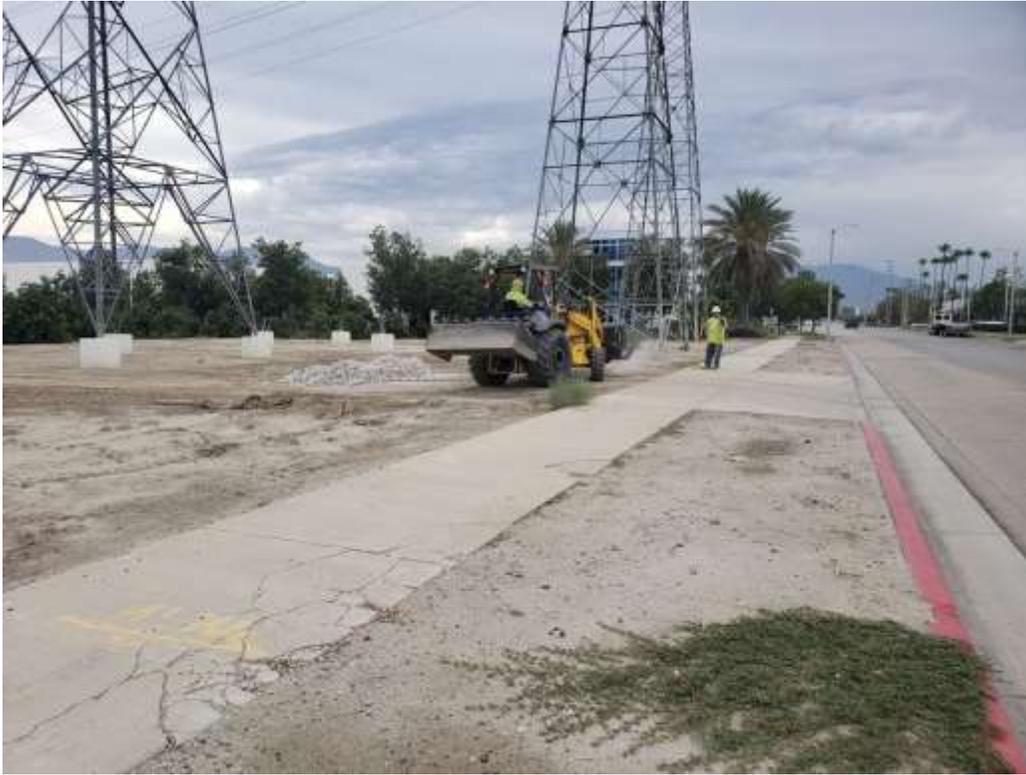
Photo 1 – BMP repair at Construction Area 1W22 on Segment 1 (August 6, 2019).

2. Work associated with Segment 1 during the monitoring period included: Coring activities at Construction Area 1X28; and BMP maintenance at Construction Areas 1X04 through 1X22 (see Photo 1).

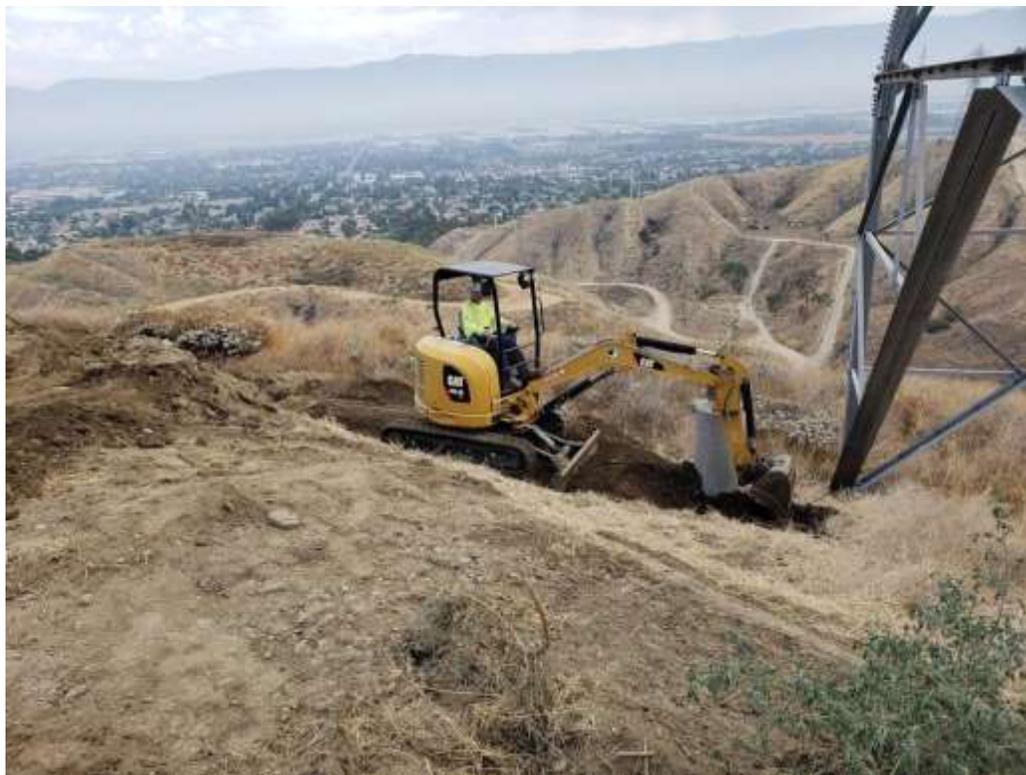
Photo 2 – Foundation wreck-out at Construction Area 2N02 on Segment 2 (August 7, 2019).

3. Work associated with Segment 2 included: Foundation wreck-out at Construction Areas 2N01, 2N02, and 1W00 (within 2N01-WSS) (see Photo 2); foundation activities at Construction Area 2X16; tower assembly at Construction Areas 2X10 and 2X11; shaker plate clean-up at Construction Area WS-2-PradoLn-MPR-27; and BMP installation at Construction Areas 2X31 and 2X32.

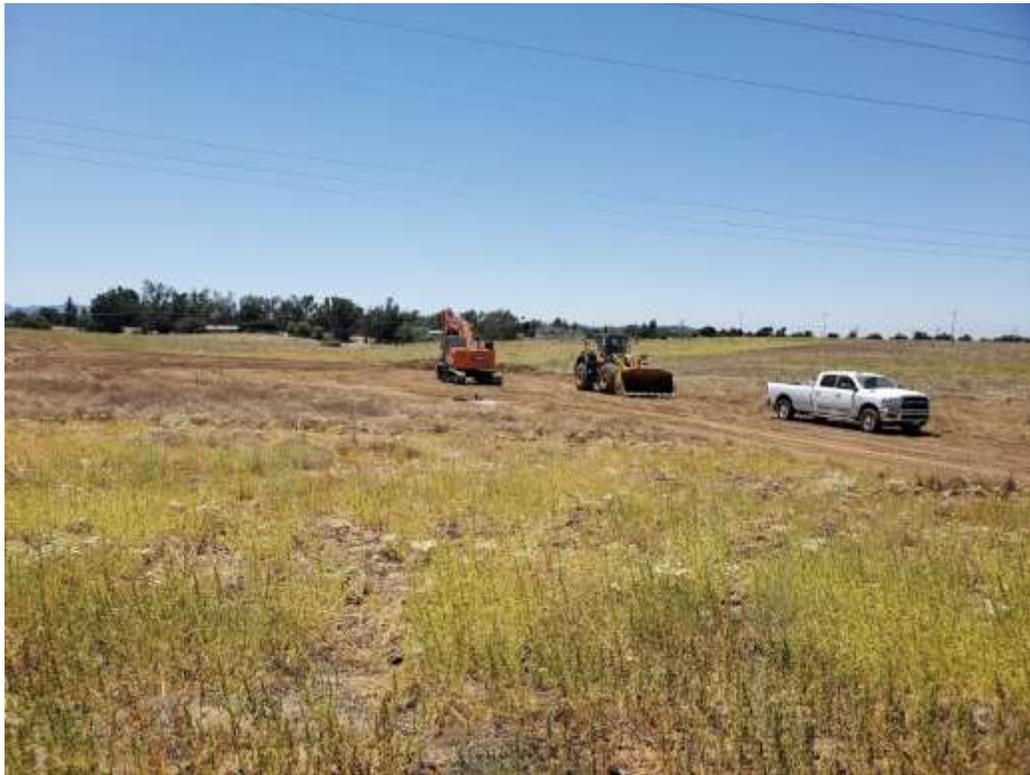
Photo 3 – Grading activities at Construction Area 4X33 on Segment 4 (July 30, 2019).

5. Work activities associated with Segment 4 included: BMP installation at Construction Areas 4X14 through 4X25 and 4X37; vegetation clearing at Construction Area 4X32; grading at Construction Areas 4X33, 4X34, and 4X36(see Photo 3); soil export at Construction Areas 4X34 and 4X37; soil import at Construction Area 4X32; fixing jumpers at Construction Area 4N65; access road maintenance from Construction Area 4X30 through 4X35; repair of irrigation line at Construction Area 4N37; and hydroseed watering at Construction Areas 4N59, 4N60, 4N61, and 4N63. Ancillary telecommunication work included pulling box and fiber cable off Tower M24-T2 at Construction Area 4X37 and removing a telecommunications box off Tower M17-T2 at Construction Area 4X01.

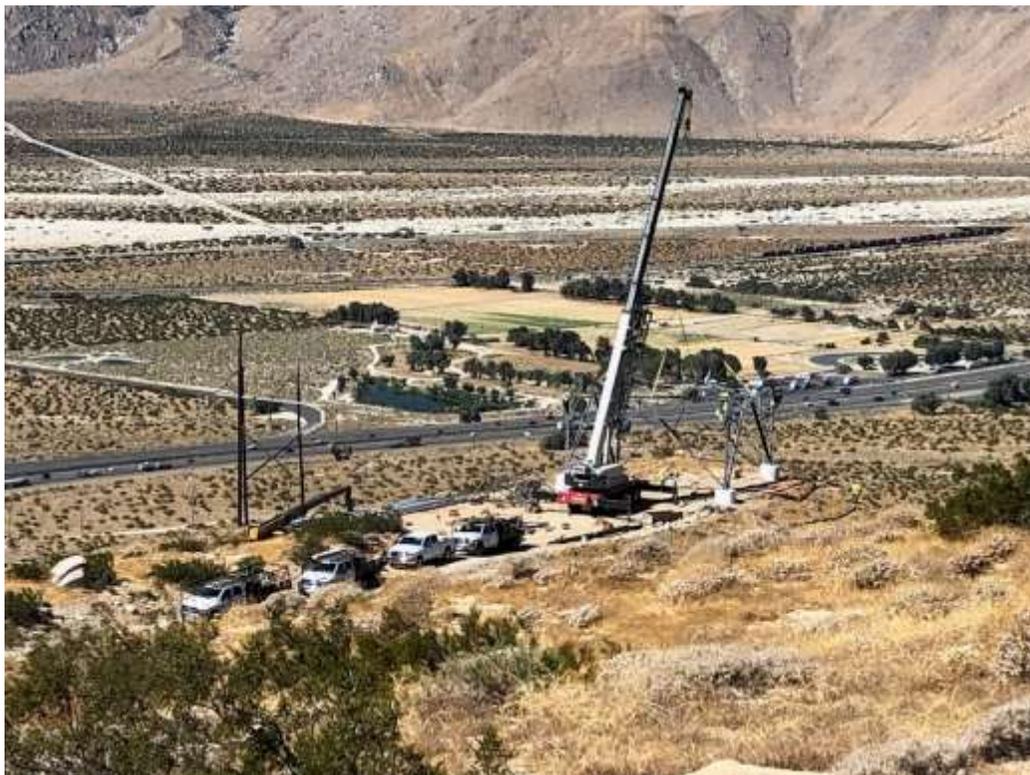
Photo 4 – Tower assembly at Construction Area 6S28A on Segment 6 (August 9, 2019).

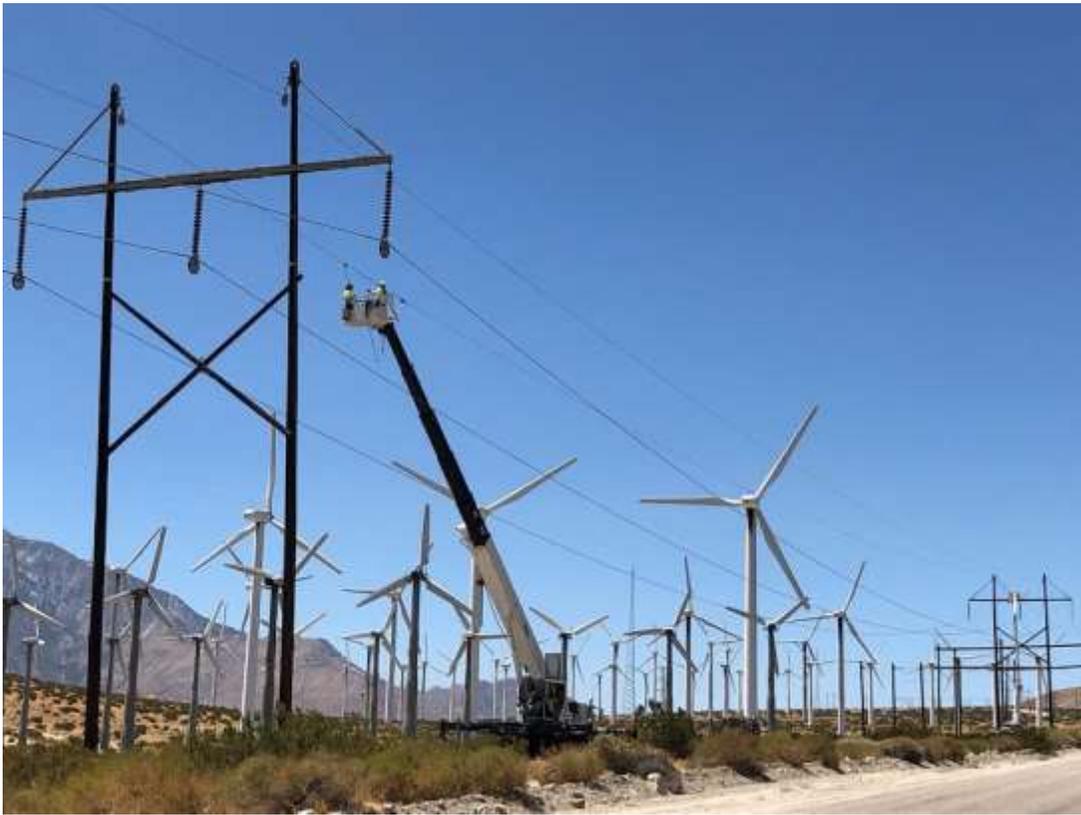
Photo 5 – Wire wreck-out activities at Construction Area T260 on Segment 6 (August 8, 2019).

snubs at Construction Area WSS-6-6S34-1-MPR-29; and wire wreck-out activities including guard pole installation from Construction Area 6X10 (Tower T271) through 6S27 (tower T252) (see Photo 5). Ancillary telecommunication work included removing a splice box from Tower M1-T1 at Construction Area 6N15.

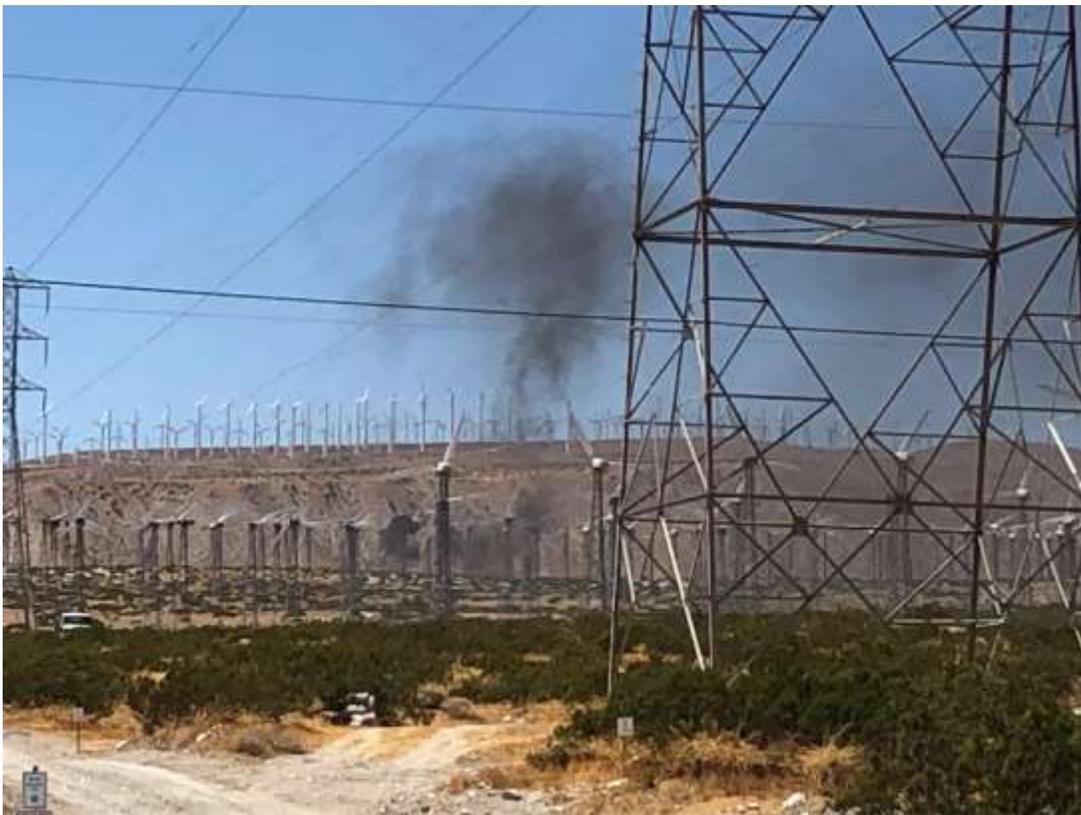
1. There were two SCE self-reported incidents and four non-project related observations during the monitoring period. On August 5, a biological monitor discovered an uncovered washout bin with three inches of standing water at Construction Area 6S18 during morning sweeps. The cover was nearby indicating it was improperly secured to ensure it wouldn't be blown off in the heavy winds of the area. The crew was notified of the incident and a level 1 was issued. On August 10, a construction vehicle was observed at Construction Area 6S32 prior to the area being swept by a biological monitor. The biologist explained to the construction personnel how important it is to contact the biologist to ensure access roads have been swept prior to entering the right-of-way and a level 1 was issued. The non-project related observations were of trash being dumped near the right-of-way, vegetation clearing by city crews near Construction Areas, and a wind turbine fire near Construction Area 6X24 (see Photo 6). In the process of extinguishing the fire, three city fire trucks and one BLM fire truck crushed grasses and creosote in the northern portion of the temporary disturbance area in Construction Area 6X24.

Photo 6 – Wind turbine fire adjacent to right-of-way and Construction Area 6X24 on Segment 6 (August 8, 2019).

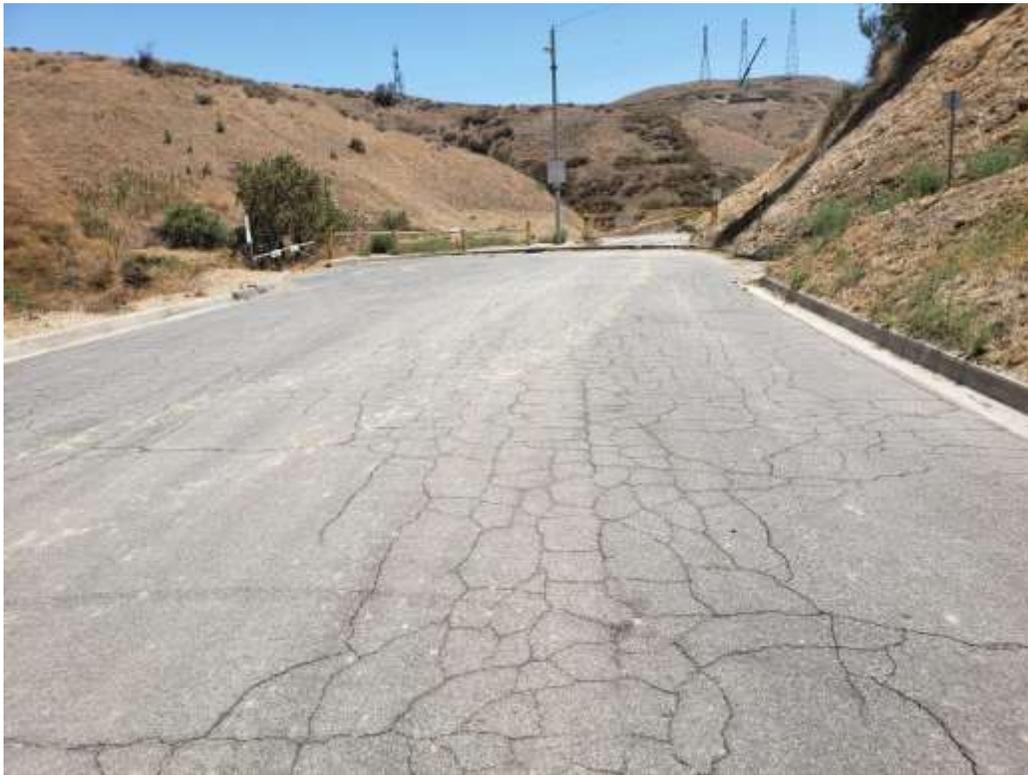
2. There were three SWPPP maintenance items or corrective actions associated with NTP #4 recorded during the monitoring period on Segments 2, 3 and 6. These include sediment build-up on shaker plates and BMP repairs at Construction Areas. On August 8, the CPUC EM observed track-out onto the paved road on Richardson Street from the access road leading to Construction Area 2N11 (see Photo 7). The CPUC EM contacted the Environmental Compliance Lead with the observation and was informed the track-out would be swept by the end of the day. To date, there are no open SWPPP maintenance items or corrective actions associated with NTP #4.

Photo 7 – Track out at construction entrance to 2N11 on Segment 2 (August 5, 2019)
